CASE HISTORY (EI-32A Quarters – Timber Piling Repairs)

CASE HISTORY (EI-32A Quarters)

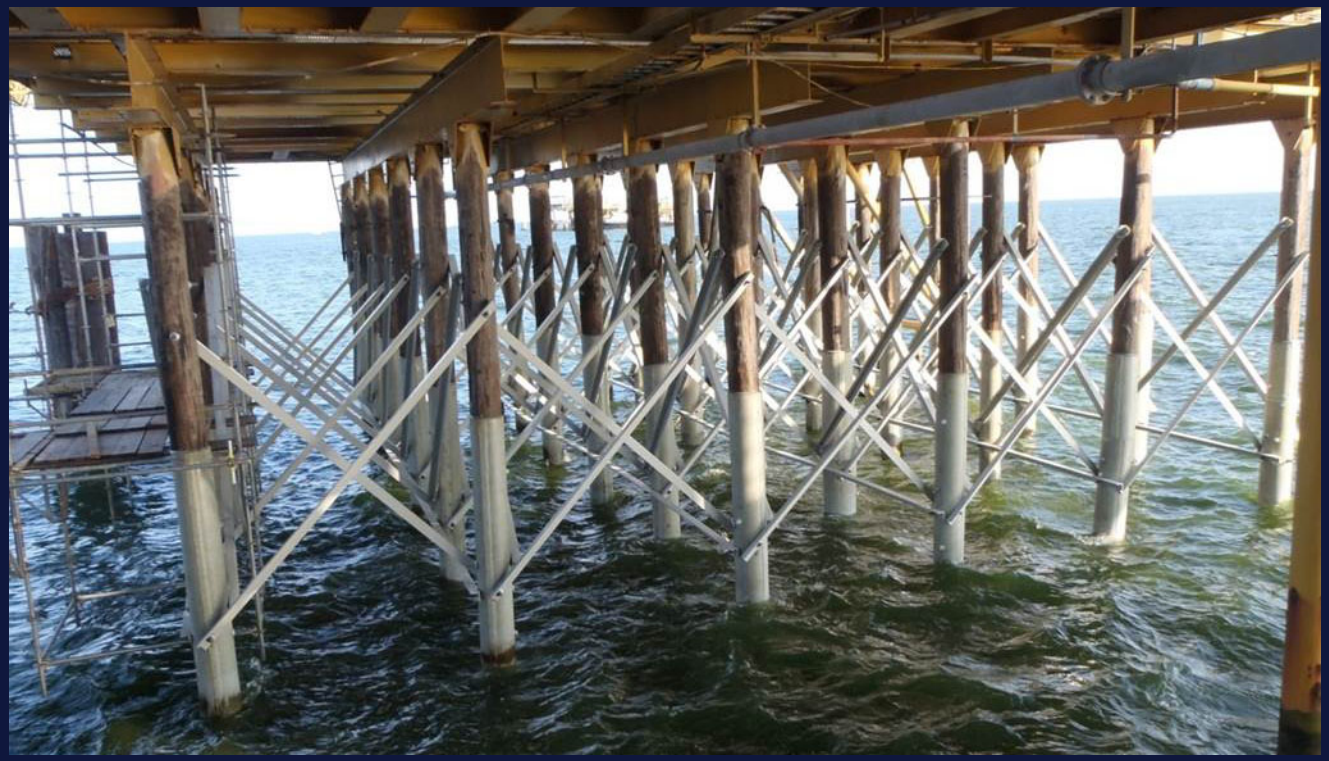
Severely Deteriorated Pile- Type I

Total Loss Of Section- Type II

- Offshore living quarters supported by timber pilings.
- Timber pilings had severely deteriorated and the operator was forced to de-man the living quarters.
- MADCON provided a full structural repair to all pilings utilizing our proprietary repair techniques.
- Living quarters were placed back in service.
